# Manhole Inspection Summary

Manhole # S11S\_\_021MH

Insp Date: **4/3/08 3:04 PM**

**Location** Address: **701 S. Caton Ave**

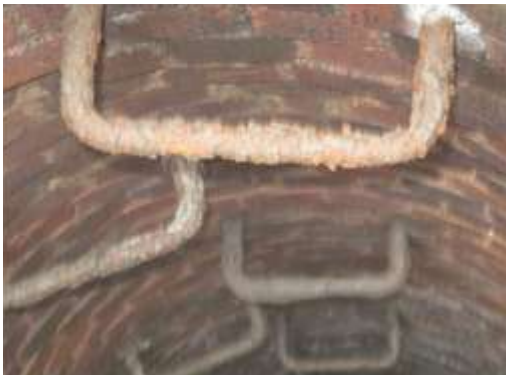
Defect 2

**Steps** Count: **11** Missing: **0** ☒ **Corroded**

corroded steps

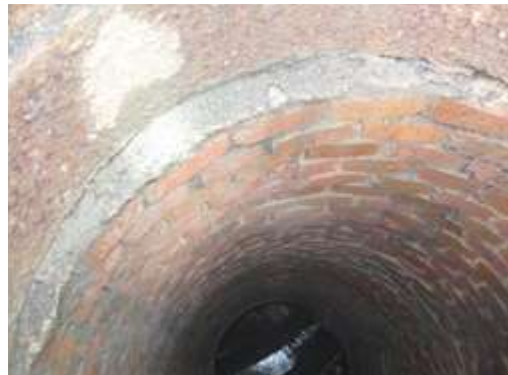
Defect 1

**Frame** Offset: **2** (in.)

frame offset 2"

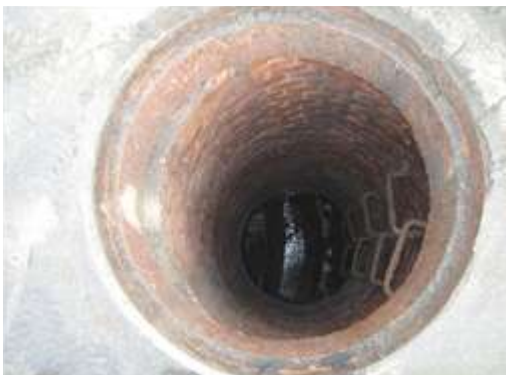
Defect 3

☒ **Leaks**

frame leaks

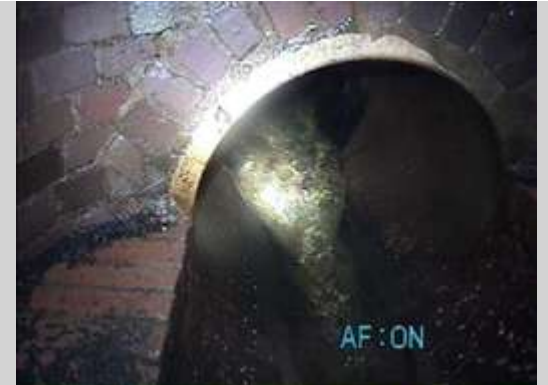
12 O'Clock Outflow

24 in. Circular Gravity Sewer  
Pipe Out @ 12 O'Clock

Pipe Height: **24** (in.) Rod and Bar (Angled)  
Pipe Material: **Clay** ☐ Pipe Lined  
Invert Depth: **19.20** (ft.) Flow Characteristics: **Fast**  
Deposits: ☒ None ☐ Mud ☐ Sludge ☐ Debris ☐ Grease  
Silt Depth: **0** (in.) Deposits Extent:  
Infiltration: **Evidence** Pipe Seal Cond: **Unknown**

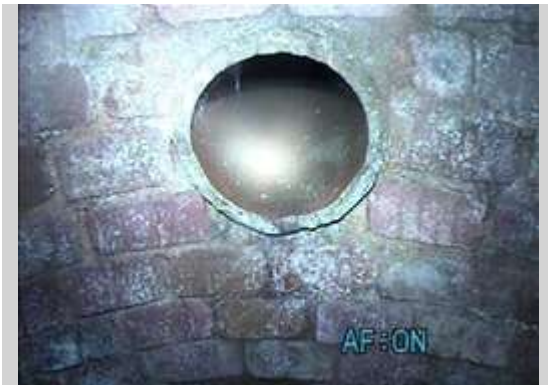
5 O'Clock Inflow

6 in. Circular Gravity Sewer  
Pipe In @ 5 O'Clock

Drop In @ 5 O'Clock

Pipe Height: **6** (in.) Rod and Bar (Angled)  
Pipe Material: **Clay** ☐ Pipe Lined  
Invert Depth: **13.20** (ft.) Flow Characteristics: **Slow**  
Deposits: ☒ None ☐ Mud ☐ Sludge ☐ Debris ☐ Grease  
Silt Depth: **0** (in.) Deposits Extent:  
Infiltration: **Evidence** Pipe Seal Cond: **Unknown**

Drop: **Inside** Rod and Bar  
Angled: **Yes** Reading: **16.10** (ft.)  
Inv Depth: **17.10** (ft.)

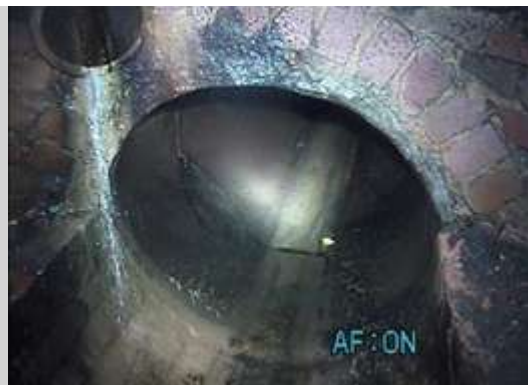
6 O'Clock Inflow

24 in. Circular Gravity Sewer  
Pipe In @ 6 O'Clock

Infiltration: **Evidence**
